**HOPE CREEK GENERATING STATION**

**INDEPENDENT ASSESSMENT OF HOPE CREEK REACTOR  
RECIRCULATION SYSTEM AND PUMP VIBRATION ISSUES**

**November 12, 2004**

**Sargent & Lundy LLC**

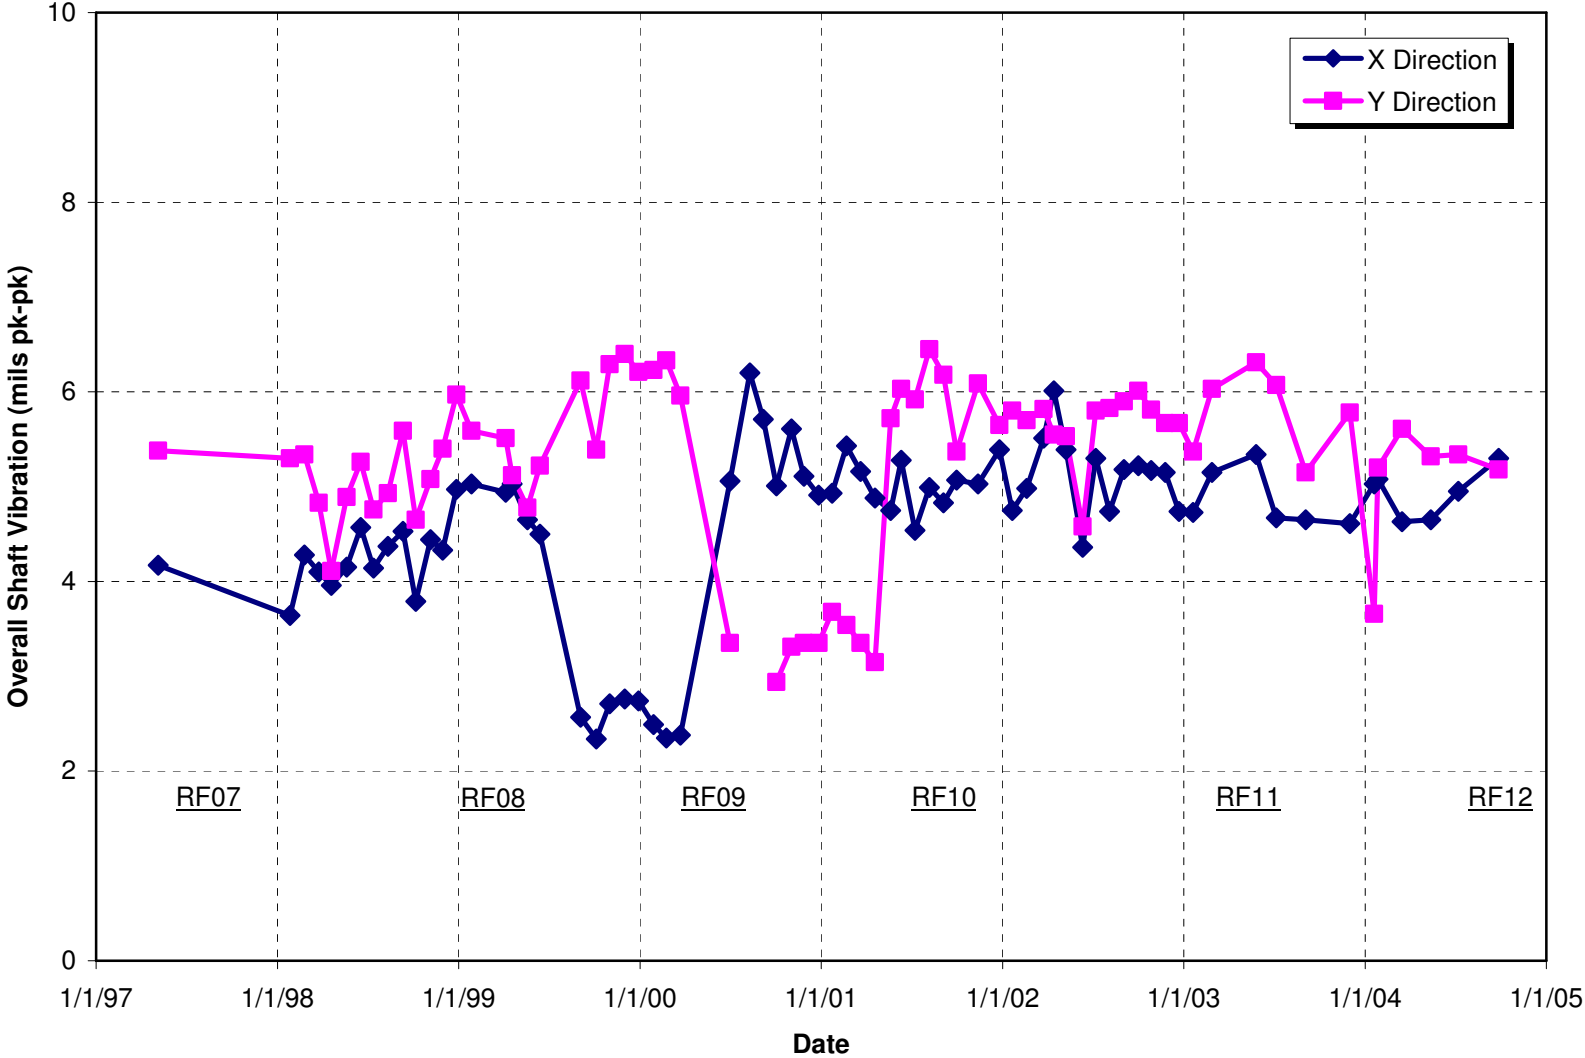
**Exhibit 5-1.**  
**RR Pump A Vibration Trends**

The RR pump vibration levels and trends were reviewed to identify signs of excessive vibrations or pump degradation. The available vibration data were in terms of pump shaft displacement measured by two proximity probes on each pump. Trends of overall vibration amplitude dating back to 1997 are provided in Exhibits 5-1 and 5-2. The 'A' RR pump vibrations are generally 4-6 mils, other than some unexplained aberrations between RF08 and RF10, with no apparent trend up or down. Prior to RF09 and after RF11 the 'B' RR pump vibrations are generally 9-11 mils with no apparent trend up or down.

The "B" pump vibrations are approximately two times higher than the "A" pump vibrations. This is consistent with the "B" pump mechanical seals having reduced life and requiring more frequent replacement than the "A" pump mechanical seals. However, the RR pump vendor has indicated that the "B" pump vibration levels are acceptable and comparable to other plants. For comparison purposes, vibration data obtained for the RR pumps at Browns Ferry Unit 2 during power ascension is provided in Exhibit 5-3. The maximum shaft vibrations are 7 to 7.5 mils for the "B" pump and 9 to 9.5 mils for the "A" pump. Both of the Browns Ferry RR pumps have higher vibrations than the Hope Creek "A" RR pump. The most recent Hope Creek "B" RR pump vibrations are only slightly higher than the Browns Ferry "A" RR pump vibrations.

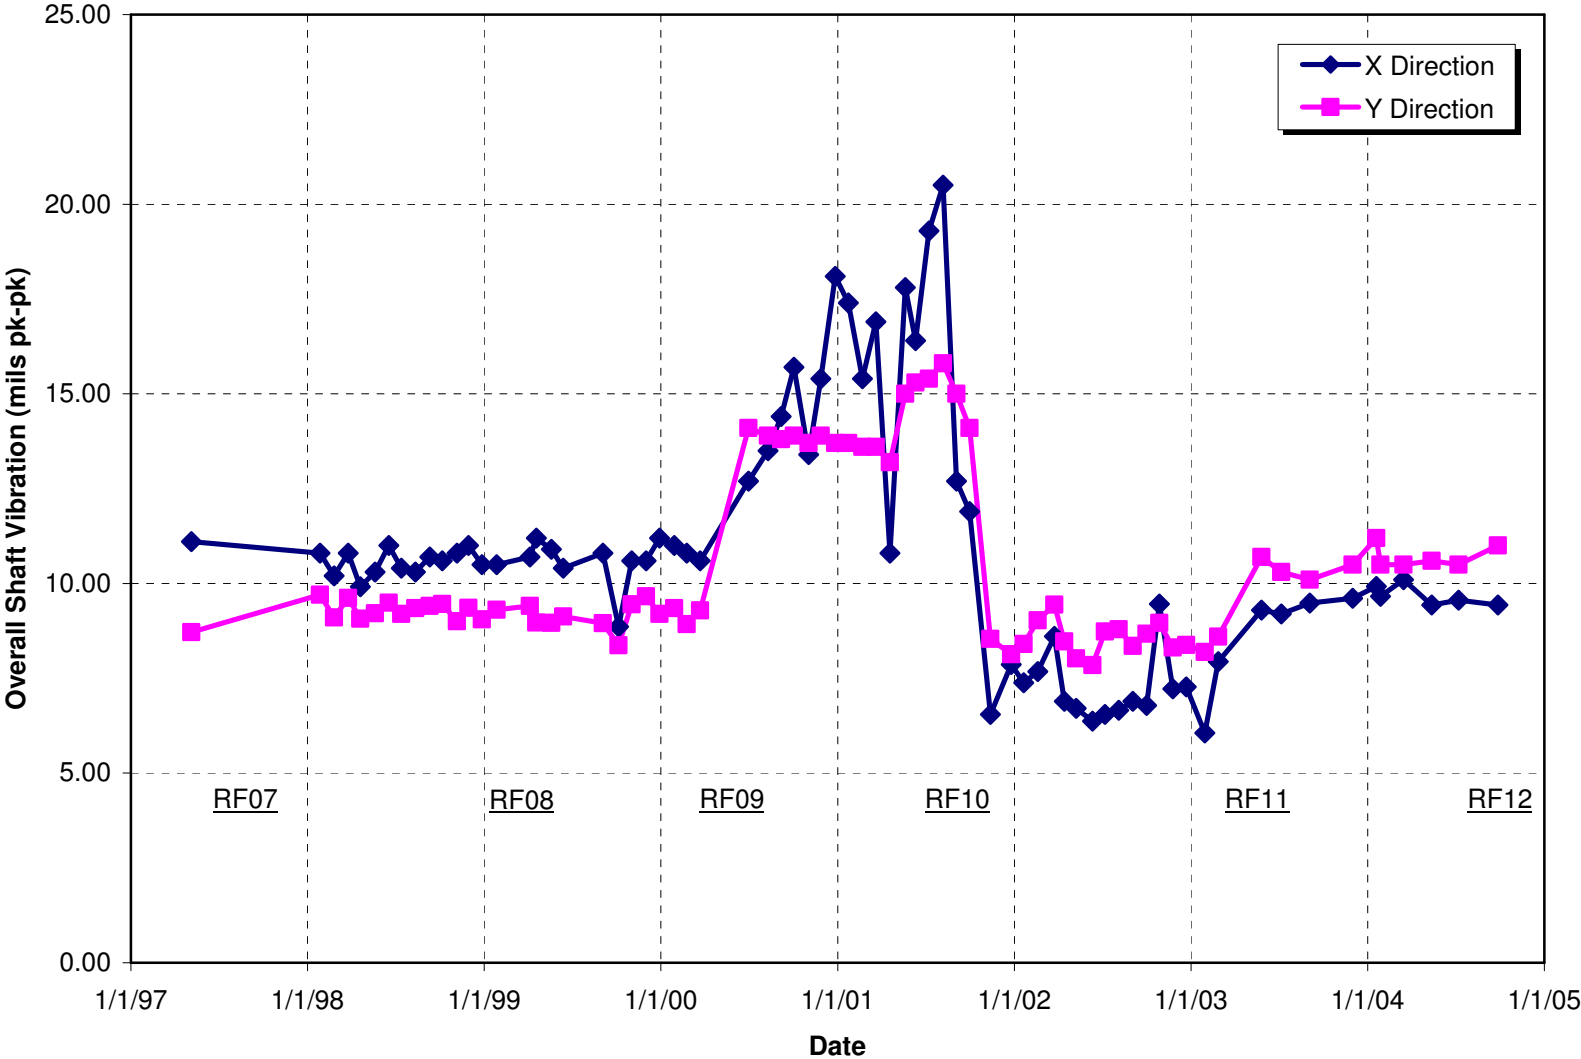
**Exhibit 5-2.**  
**RR Pump B Vibration Trends**

Operations of the "B" RR pump does not appear to be impaired by the vibration levels that were experienced. Vibration levels were stable following RF10 and RF11. (Ref. 5.9) Amplitudes after RF11 were somewhat higher than after RF10. Seals on the "B" pump were replaced during RF11 and the coupling was removed to facilitate the work. The reassembled alignment with the motor may not have been as accurate during RF11 as during RF10, which could cause the increase. However, amplitudes on the "B" pump were stable from May 2003 to the end of September 2004.
